Arboricultural Report

Tree Survey
Arboricultural Impact Assessment
& Tree Protection Plan

Land at
Woodberry Down – Phase 3
Woodberry Grove / Seven Sisters Road
London
N4

Prepared by:
The Mayhew Consultancy Ltd

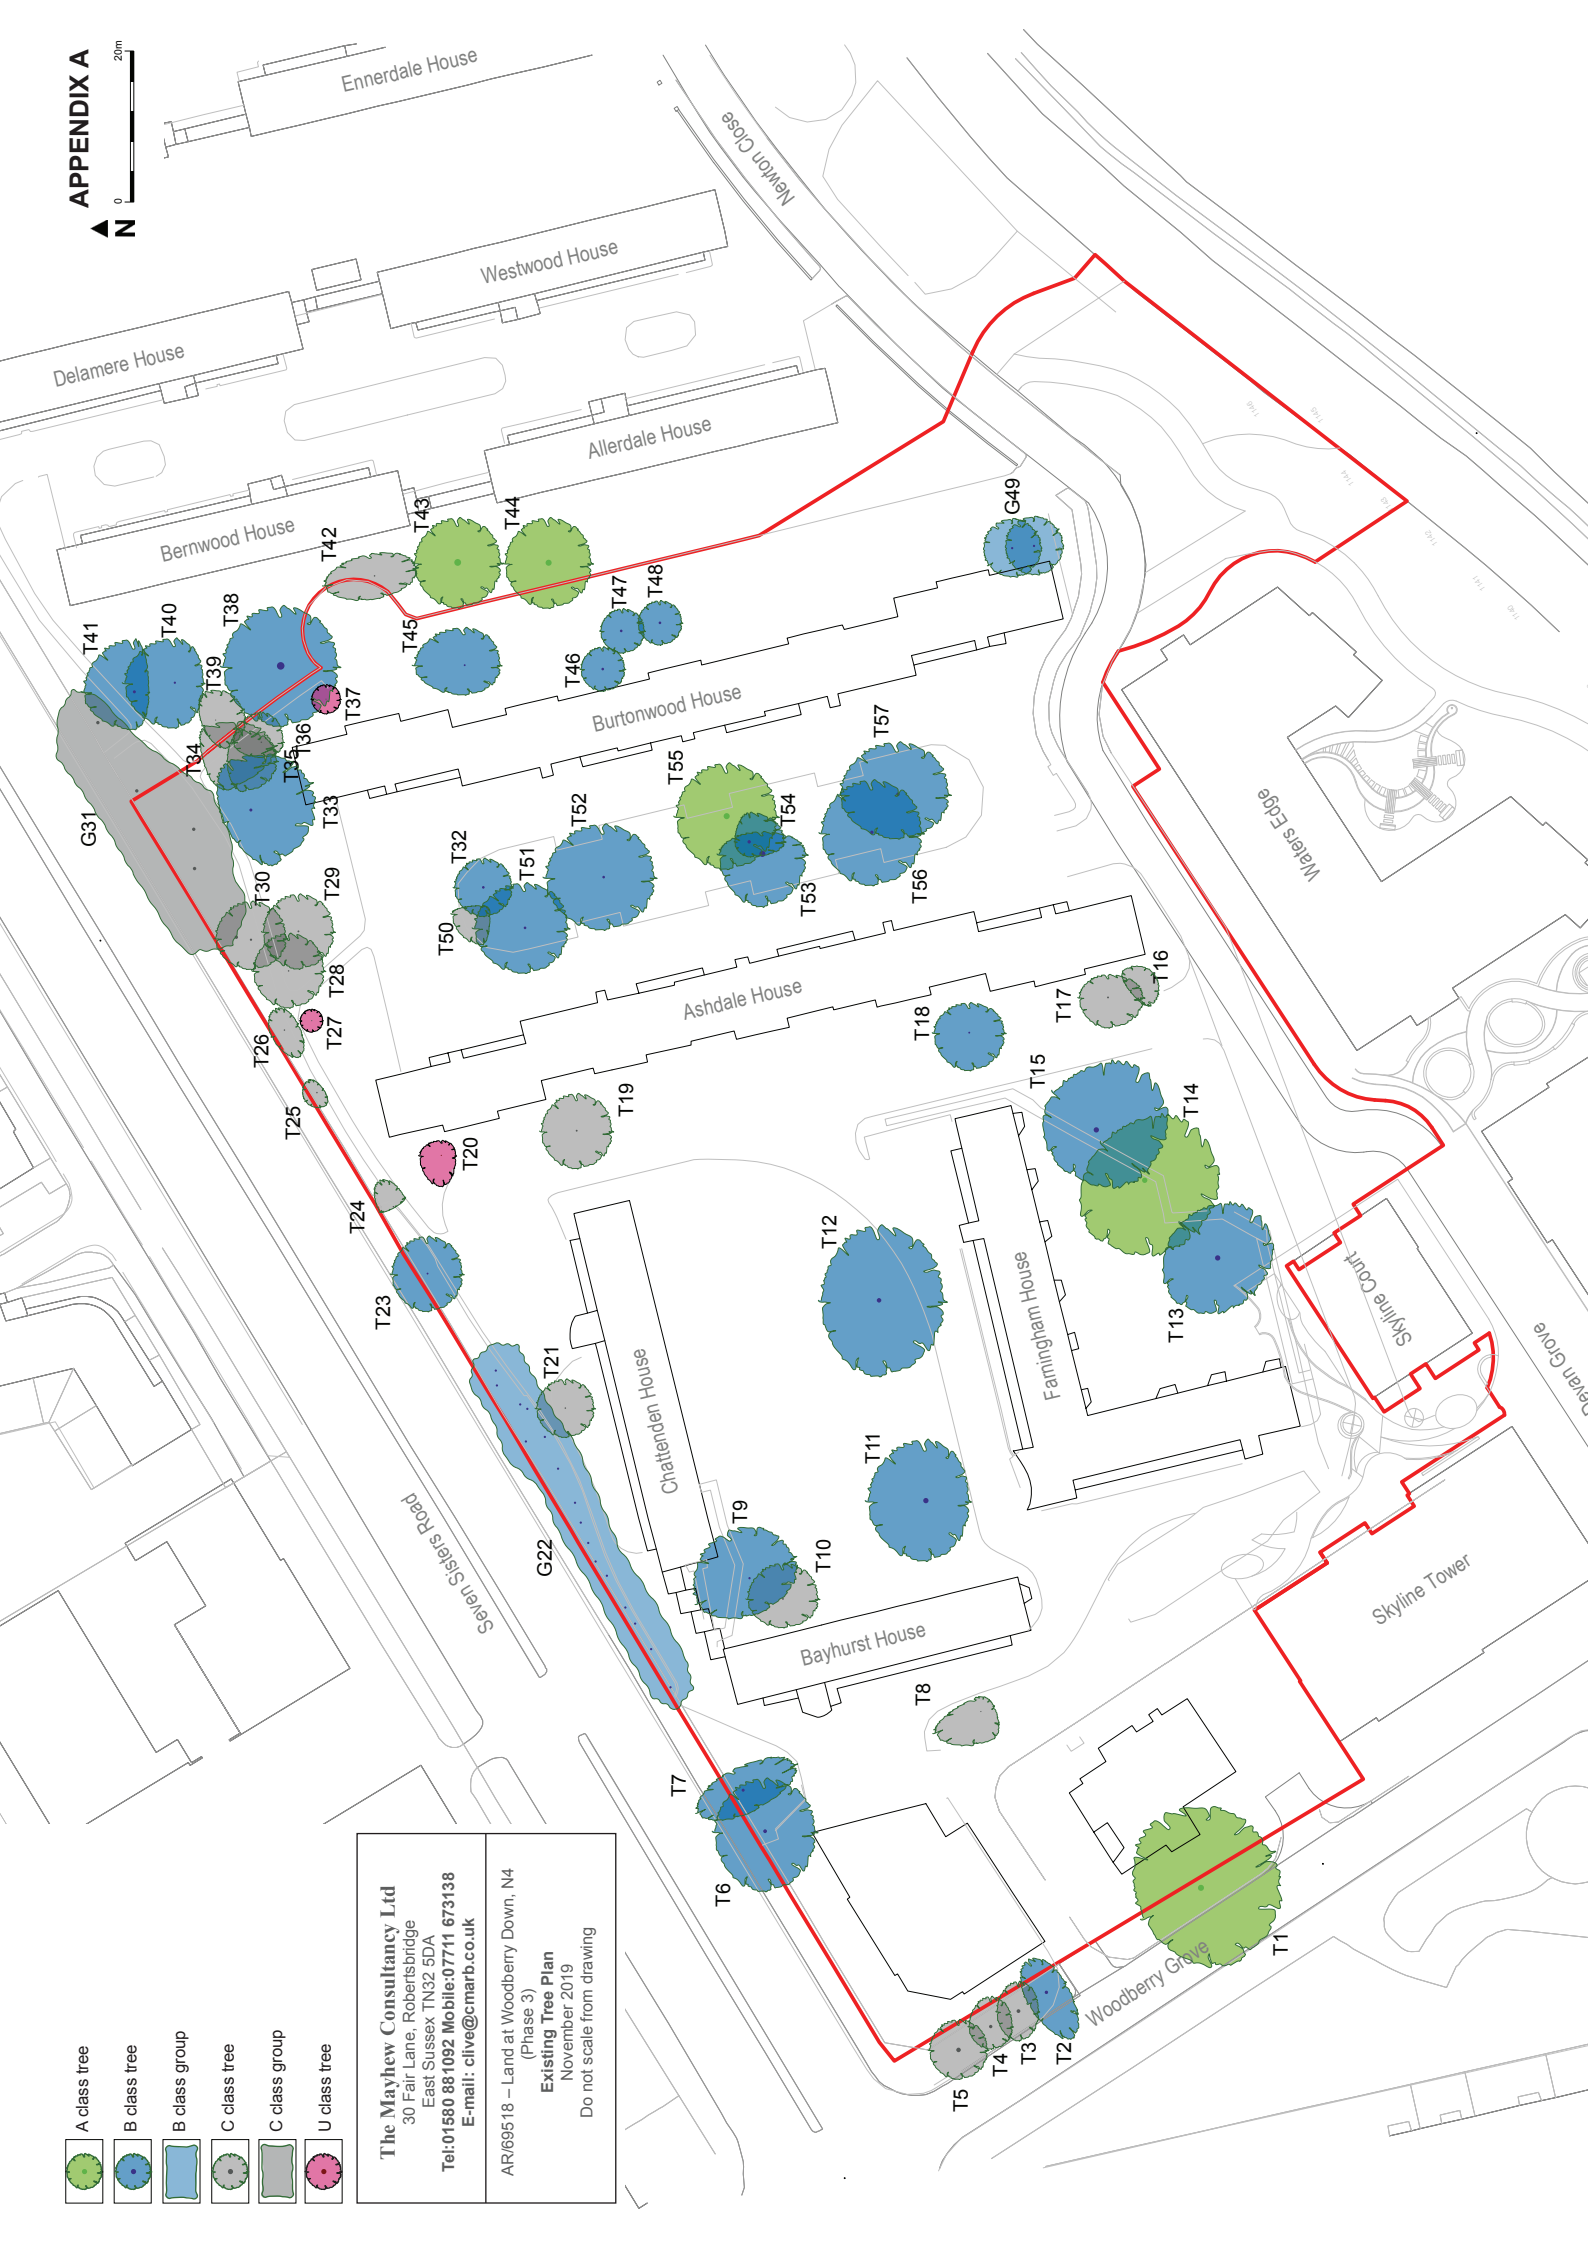
AR69518 – Land at Woodberry Down, N4
 (Phase 3)
Existing Tree Plan
 November 2019
 Do not scale from drawing

8.2.1 The individually surveyed trees are plotted at Appendix A and described in the tree survey schedule at Appendix C.

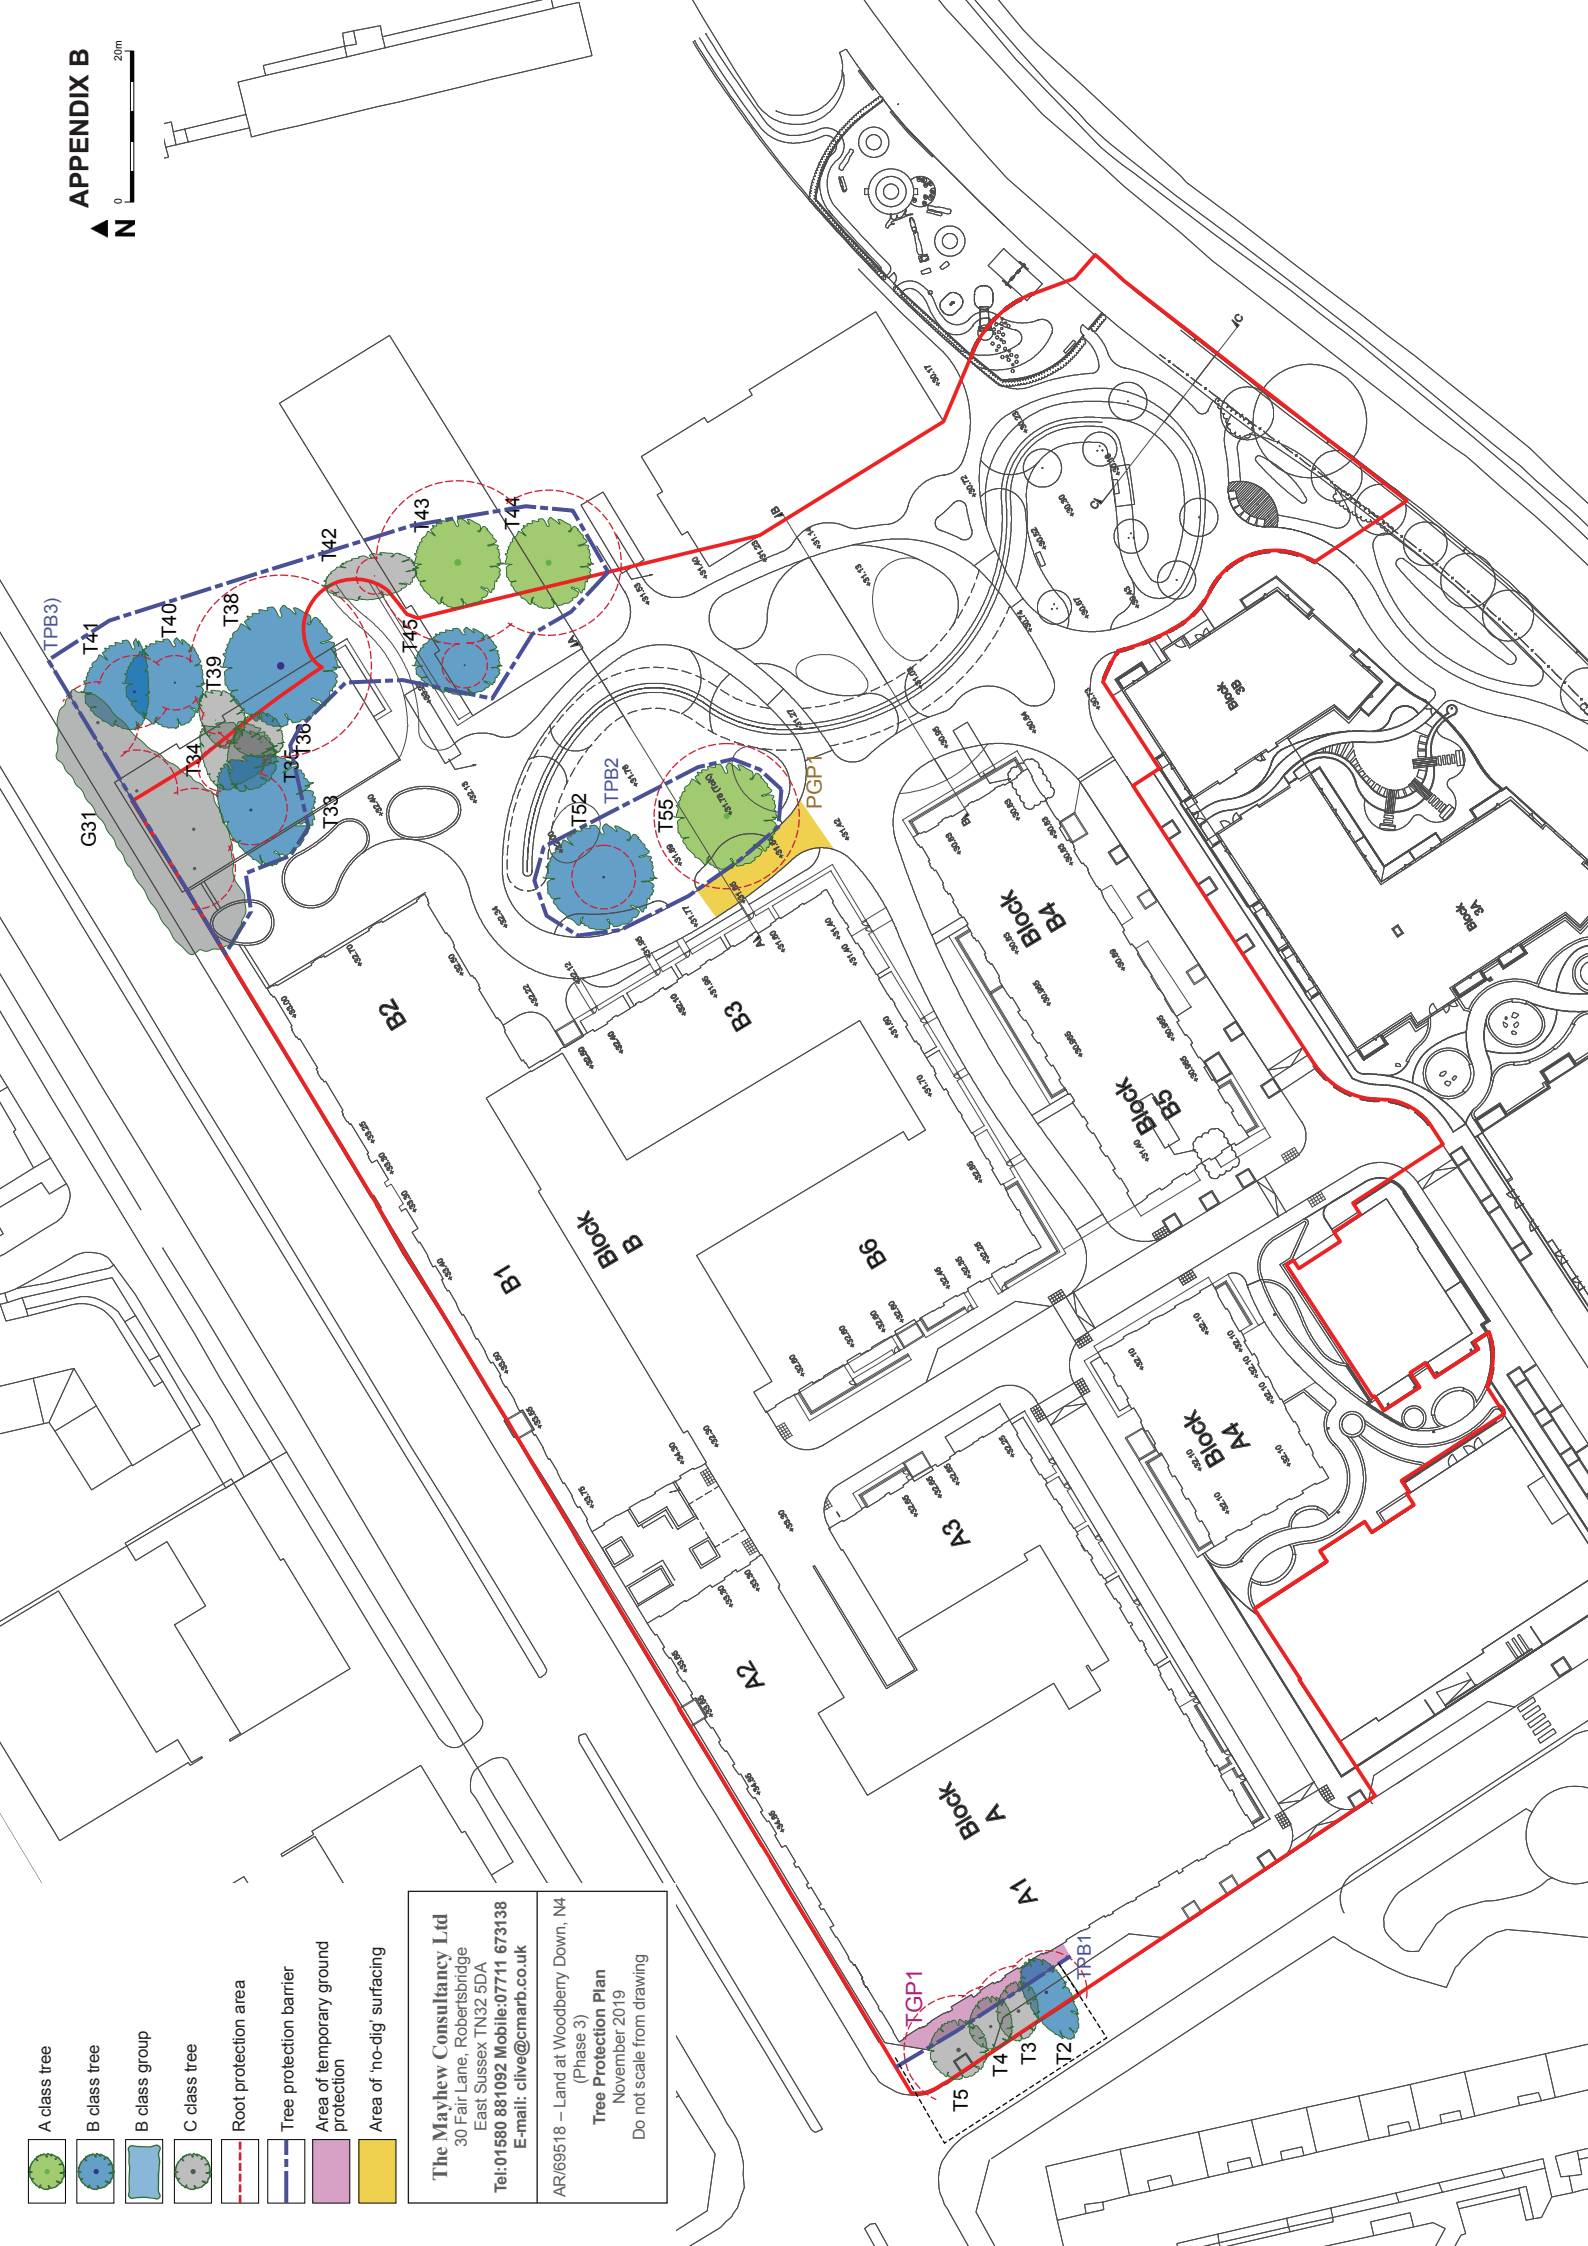
AR/69518 – Land at Woodberry Down, N4
 (Phase 3)
Tree Protection Plan
 November 2019
 Do not scale from drawing

I have calculated the RPA of the retained tree (T55 – London Plane) as recommended within BS 5837:2012. This area is shown as a dashed red line around the retained tree at Appendix B.

11.4.2 The subject site: The requirement for three Tree Protection Barriers has been identified and these have been illustrated at Appendix B.

- **TPB 1** - This barrier is located adjacent to T2 – T5. It is designed to protect the stem and root system of that tree from being damaged during the construction period; in practice this barrier is likely to be incorporated into the external site fencing.
- **TPB 2** - This barrier is located around T52 and T55 within the proposed post-construction area of open space. The installation of this barrier is designed to protect the stems and root systems of these trees during the construction period.
- **TPB 3** - This barrier is located around trees within the north east corner of the site, these trees being identified for retention until the consideration and commencement of Phase 5. The installation of this barrier is designed to protect the stems and root systems of the trees during the implementation of Phase 3.

11.5.1 The subject site: A requirement for one area of temporary ground protection has been identified and these are illustrated in pink at Appendix B.

- **TGP 1** – This area of ground protection is located to the east of T2 - T5. It is designed to provide working space by providing protection to the RPAs of those trees. In order to achieve that aim, the ground protection should completely fill the gap between the perimeter fence and the proposed building. It should also be of a suitably robust specification to withstand the degree of proposed activity anticipated within the area.

11.6.1 The subject site: A requirement for one area of permanent ground protection has been identified; it has been illustrated in orange at Appendix B.

- **PGP 1** - This area is located to the west of T55 and encompasses a section of the proposed internal access road within the development. It is designed to provide protection to the RPA of adjacent T55.
